# INTERVENTION PLAN FOR THE RESTORATION OF PALACE ARRUABARRENA, CONCORDIA, ENTRE RÍOS, ARGENTINA.

A. Bruno  
L. P. Traversa  
J. D. Sota

GIICMA -UTN Universidad Tecnológica Nacional -Facultad Regional  
Concordia, Concordia, E.R., ARGENTINA - glicma@frcon.utn.edu.ar

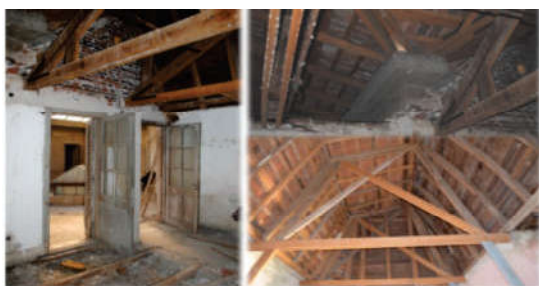
Figure 11.

Regarding the state of conservation of the wood elements of the openings and the structure of the roofs, an alteration was observed by the contact with rainwater, which in some cases, particularly in the shutters, is more severe. Visually no signs have been observed due to the attack of insect species that degrade this type of material. The pathologies are observed in the photographs: (Figure 11 - 12 - 13 - 14 and 15)

d) For the wooden elements it would be necessary to carry out a sampling in particular in the elements that make up the structure of the domes, in order to carry out studies and observations that allow to determine the existence of a biological attack caused by insects, as well as to proceed the preservation of wood through the application of suitable products.

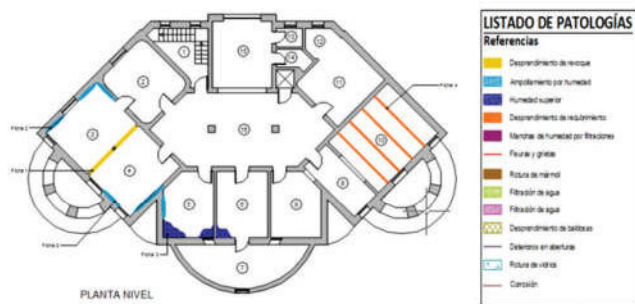
Figure 19.

After making the survey of pathologies, we proceed to locate them in planes, with the objective of quantifying the damages for the subsequent repair, (Figure 19 and 20) and a list of identified deteriorations, (Figure 21).
