INFLUENCE OF CEMENT MATERIALS' COMPOSITION ON MICROBIOLOGICAL COLONIZATION OF DAMS

ABSTRACT

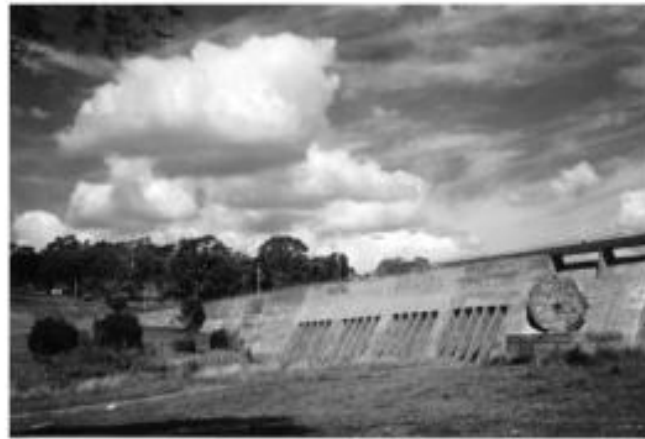
It is curious to note that lichen species have a clear distribution pattern in the dams of Tandil (Figure 1) and Azul (Buenos Aires province, Argentina): the yellow species grow in the upper part; the grey/green species are in the middle part and the black species in the lower part. This distribution pattern was also described in the Covenham wave Wall (Lincolnshire, U.K.) in a sea environment, and has been attributed to differences in superficial moisture. This is probably the case here, because the concrete retains quite a great percentage of water.

Figure 1. Tandil dam (Buenos Aires province, Argentina).

As for the impact of these colonisations, lichens, and other phototrophic organisms may cause mechanic and chemical weathering, but it is only superficial and does not affect the structure. In the case of the Tandil dam in Buenos Aires Province, observations with Scanning Electron Microscope (SEM) showed that the hyphae of the mycobiont, fungal partner of the symbiosis of the lichen *Caloplaca austrocitrina*, penetrate the material. As the hyphae absorb water from the environment, they grow and expand, so the turgor pressure increases, exerting forces on the material and causing damage to microscopic structure of the mortar. This mechanism generates boring channels causing a micropitting (perforations between 10 – 20 μm). Electron dispersive Spectrometry (EDS) revealed that the material affected by lichens

had very low calcium content of 5.3%, compared to the 59.4% of the non-colonized concrete, whereas optic microscope observations of thin sections gave as result that *C. austroclitina* penetrated the cement material up to 1 – 1.5 mm (Traversa et al., 2000; Traversa et al., 2001). However this is considered mostly as an aesthetic problem, not affecting the safety or the operation of the dam; and so, cleaning is not performed, as the costs would be too high, without a clear benefit. The case of flowering plants is different, because their roots exert pressure on the material increasing the size of fissures. However, plants were not observed in the Buenos Aires dams and were not mentioned for Covenham, either. In the case of the Tucumán dam, only small *Tillandsia sp.* was seen, but these are epiphytes, without a well developed root system. A very important biodeterioration problem for dams is the presence of mussels. We must mention the golden mussels (*Limnoperna fortunei*) that invaded the Paraná and Uruguay rivers up to the South of Brazil. These species can reach densities higher than 100,000 ind./m² and cause great economic losses due to obstruction of pipelines, interruption of the function of different systems, cleaning, repair, lost profits, etc. Like other mussels, *L. fortunei* has a system to attach it to the substrate by means of an inert sclerotized structure formed by threads called “byssus”, which penetrates the material of the colonized substrates and can produce deterioration of concrete structures (García et al., 2011).

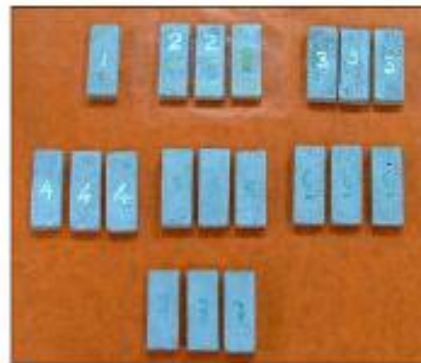
Figure 4. Mortar specimens.

As described by Prunell et al. (2011), normal cement mortar test samples dosed with different percentage additions of lime filler and puzzolan (Table 1) were cast in acrylic forms of 11 cm × 12 cm (Figure 3) that yielded 3 specimens of 1 cm × 6.5 cm × 2.5 cm each (Figure 4). Once freed from the mold, test samples were cured during 28 days and subjected to artificial carbonation in the CO₂ chamber during one week. The samples were placed in sterile 500 mL containers prepared with vermiculite covered by a filter paper, wetted with 40
