# INTERVENTION PLAN FOR THE RESTORATION OF PALACE ARRUABARRENA, CONCORDIA, ENTRE RÍOS, ARGENTINA.

A. Bruno  
L. P. Traversa  
J. D. Sota

GIICMA -UTN Universidad Tecnológica Nacional -Facultad Regional  
Concordia, Concordia, E.R., ARGENTINA - glicma@frcon.utn.edu.ar

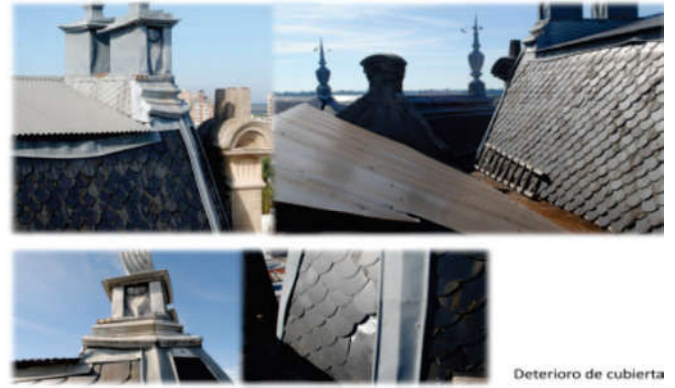
**Figure 16.**

Regarding the exterior, the most serious pathologies have been observed in constructive elements (cornices, corbels, etc.) and ornaments (statues and shields, etc.) that have led to the detachment of plaster and in some cases, such as that of a shield the total loss of the element.

The detachments and fissures in these elements have been caused by the corrosion process of the metallic bars and reinforcement plates.

c) Regarding the most difficult problem such as repair and / or replacement of exterior ornaments, it is also advisable that the tasks are developed by specialists in the subject, given that in some cases, such as the absence of one of the shields, you must use a photographic record to obtain information about the original design in order to replicate it. It is advisable to proceed to the fixation of those ornaments that are half-formed by the use of epoxy resins and stainless steel bolts.
